TECHNICAL REPORT CERC-88-16

SIDE-SCAN SONAR APPLICATIONS FOR EVALUATING COASTAL STRUCTURES

James E. Clausner, Joan Pope

Coastal Engineering Research Center

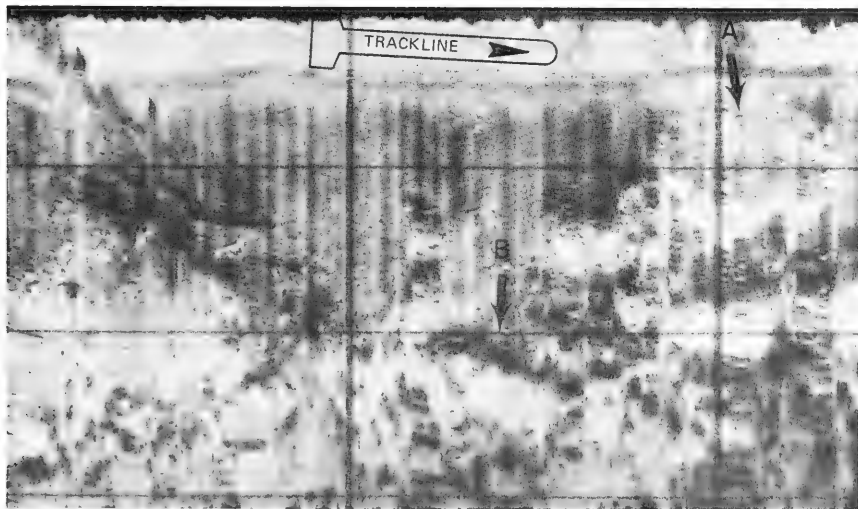
Figure 9. Dolos trunk section of the east breakwater, Cleveland Harbor, Ohio; range 50 m, towfish near surface, 500 kHz

26. In summary, the result of the various side-scan sonar surveys and diving inspections was the assessment that the underwater condition of the dolos cover has several flaws as a result of initial placement. Of primary concern are apparent depressions which may be "holes" in the dolos cover and sections where the dolos toe is perched. The side-scan sonar records reveal significant variation in the condition of the structure toe throughout the 4,400-ft-long rehabilitation. There are areas of little or no underlayer berm and other areas where the toe of the dolos cover is very steep. Also of interest is the amount of new breakage and movement observed in both the head section and transition zone during the 1984 inspection. Apparently, the dolos cover in these areas is still dynamic, and progressive deterioration is occurring.

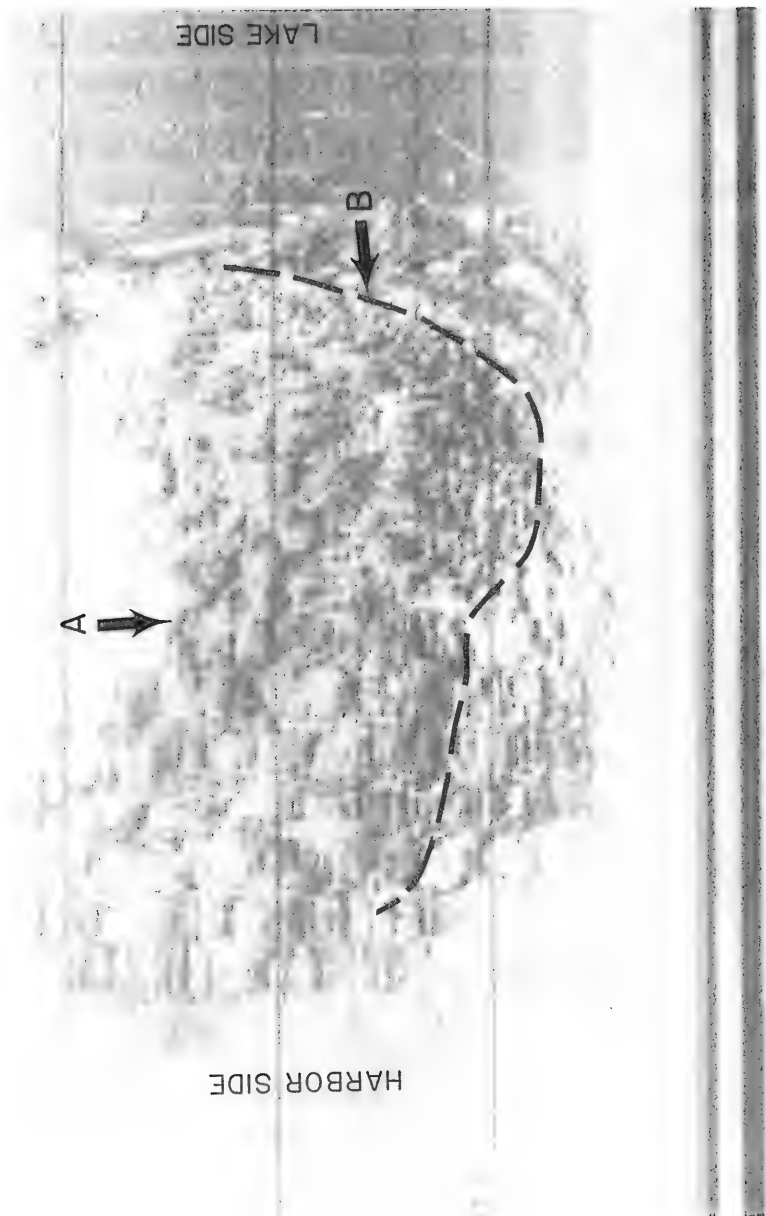
Figure 10. Dolos head section, east end of east breakwater, Cleveland Harbor, Ohio; range 50 m, 500 kHz

25. Figures 10 and 11 are from the head section and the transition between the head and the trunk, respectively. Just to the right of arrow A at the waterline (Figure 10), an indentation shows where dolosse were lost during a storm. The dashed line (Figure 10) shows the dolos toe and the exposed

underlayer stone berm. The right side of Figure 10 (Arrow B) shows an area of where the dolos toe is excessively steep and some dolosse placed in 1982 have been lost down the slope. In general, the underwater condition of the head section included a skimpy dolos cover near the toe, numerous "hangers," and more breakage near the waterline. In the transition section (Figure 11), the underlayer toe is very wide and steeply terraced. The sonograph shows transition from the head (left) to the trunk (right). The dolos toe in this area is very steep and well defined as shown by the changes in pattern along line A-A. Divers observed approximately 25 broken dolosse in this section. Although the breakage was random, there was observational evidence of some movement and instability throughout the dolos cover in this section.

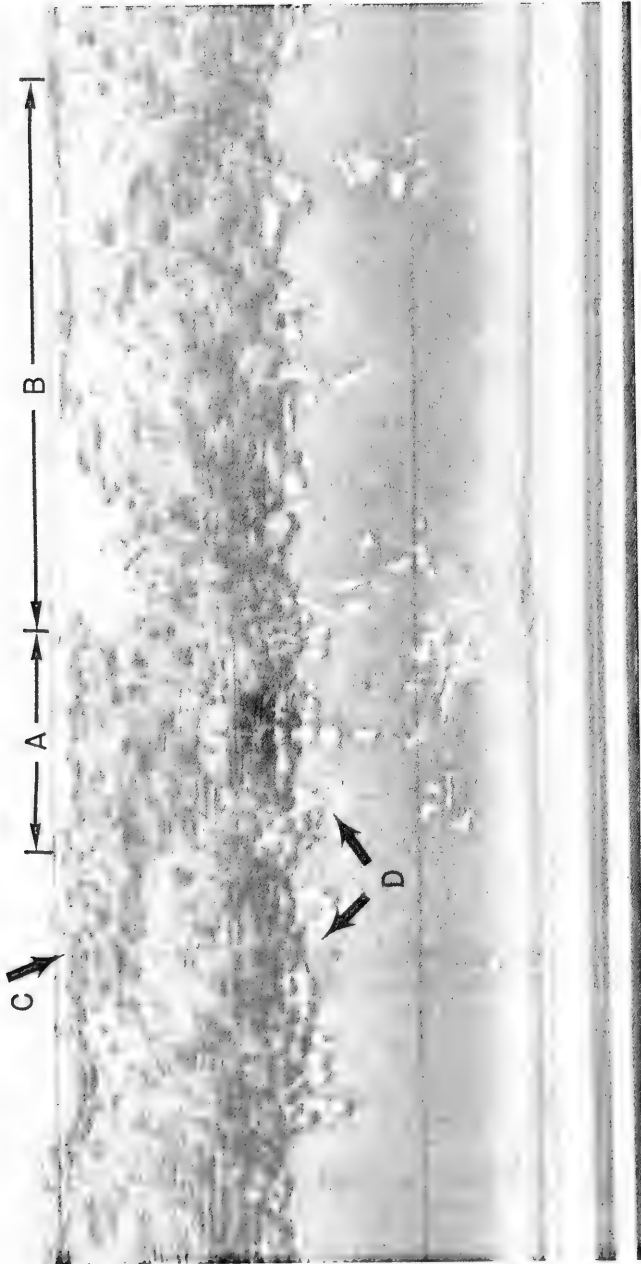
Figure 12. Laid-up block section of harbor side of east breakwater, Cleveland harbor, Ohio; range 50 m, 500 kHz

27. Cleveland Harbor offered a unique opportunity to view a variety of coastal structures. In addition to the dolos rehabilitated section, images were taken of the laid-up block breakwater sections, rubble-mound faces of dredged material containment dikes, vertical sheet-pile walls, and timber cribs. Figure 12 shows a laid-up block section (linearity caused by reflection off the edge of the stone blocks). Section A has a uniform slope, and section B has a shadowed upper slope which suggests irregularities and a deteriorated condition. Arrow C shows the waterline and D the toe. Debris and stone blocks are noticeable beyond the toe.

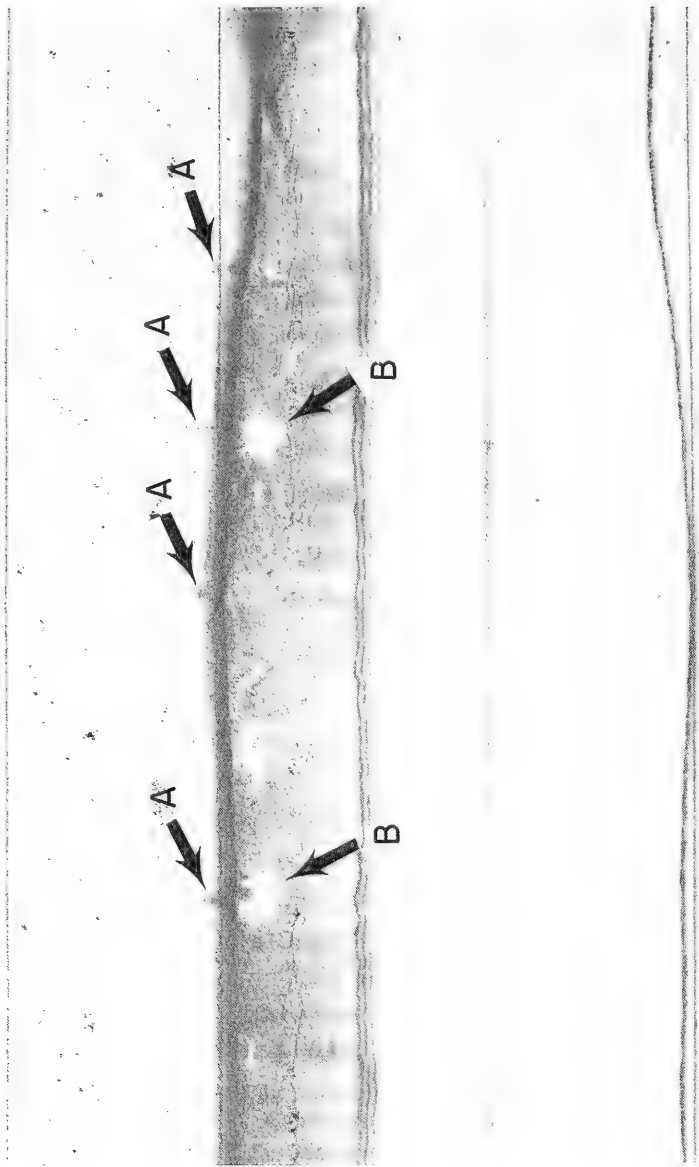
Figure 13. Timber crib section, harbor side of west breakwater, Cleveland Harbor, Ohio; range 50 m, 500 khz

28. An old timber crib section of the west breakwater was inspected from the harbor side (Figure 13). Seams between individual timber cribs were revealed as the acoustic pulse penetrated the joints (A). In addition, those

seams which were permeable to wave-induced currents were identified by the scoured depressions in the bottom sediments at the base of several of those seams (B).

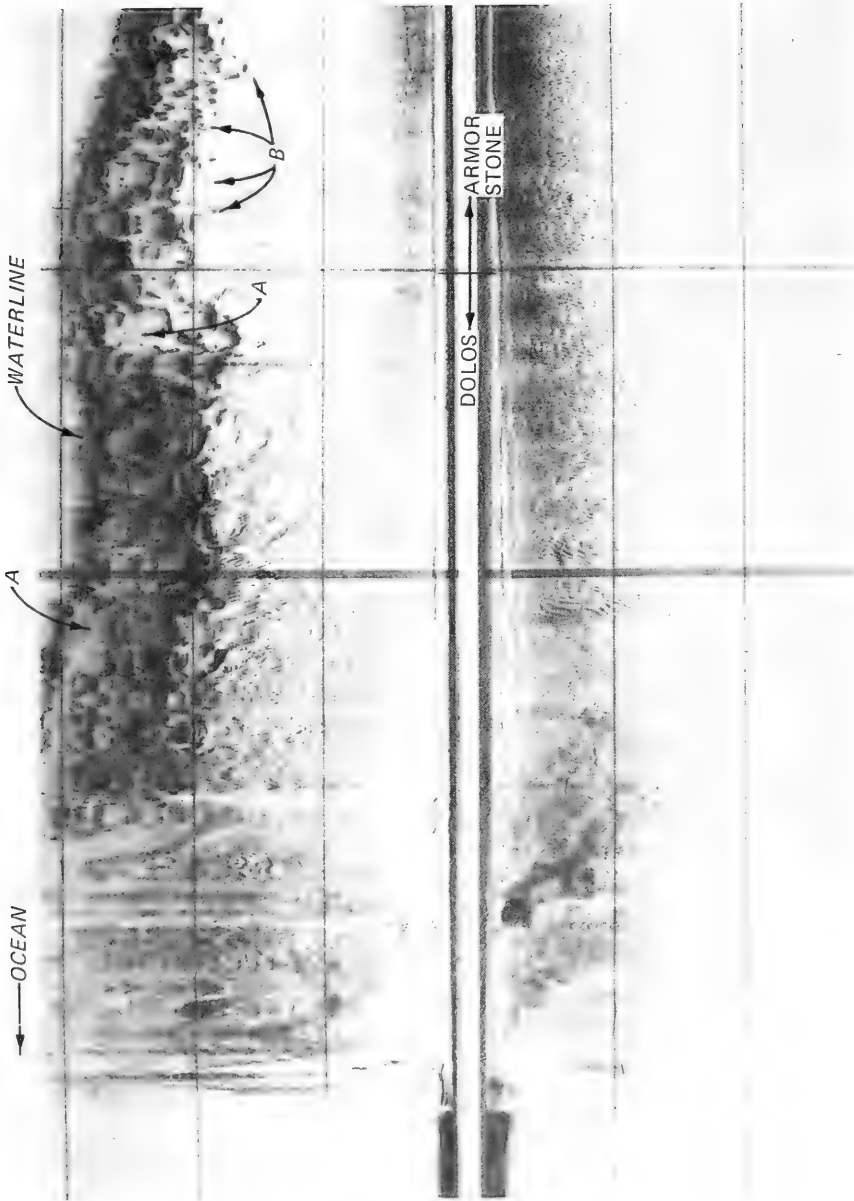
Figure 15. North side of north jetty at Manasquan Inlet, New Jersey;
50-m range, 500 kHz

31. Considering the severity of the spring storm, the above water and side-scan sonar interpreted below water condition of the structures appeared to be good overall. Still, the image of the north side of the north jetty (Figure 15) showed two "holes" in the dolos cover (A) and what are probably the tips of 12-ton armor stones (B) projecting above the sand farther to the right. It is possible that these holes were the result of poor quality control rather than the storm. Several targets that may be displaced rocks can also be seen on the record. Diver observations would be needed to positively identify these targets.

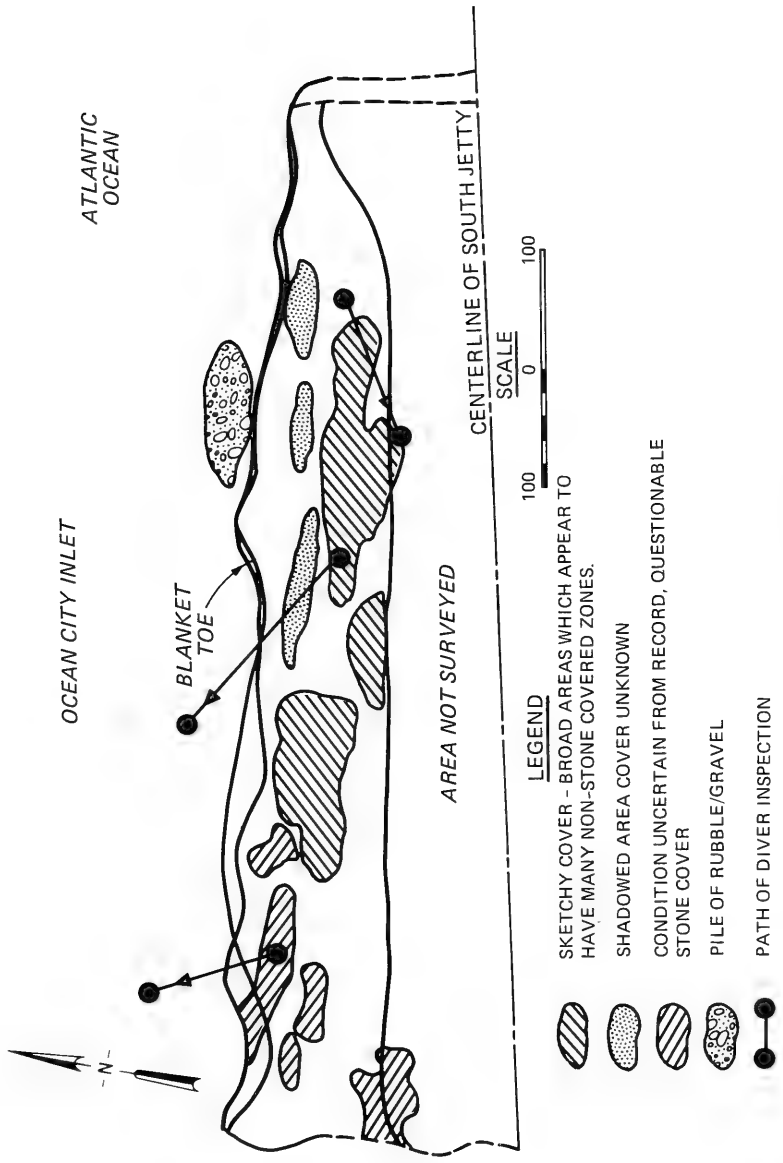
Figure 17. Map of stone blanket coverage produced from composite of several individual side-scan sonar records

then composited to create a map showing cover over the specified stone blanket area (Figure 17). Divers verified the results shown on the side-scan sonar images by traversing along the three tracklines shown in the figure. Some of the areas identified as sketchy cover were determined to be areas with adequate stone cover but where drifting sand had covered the stone.

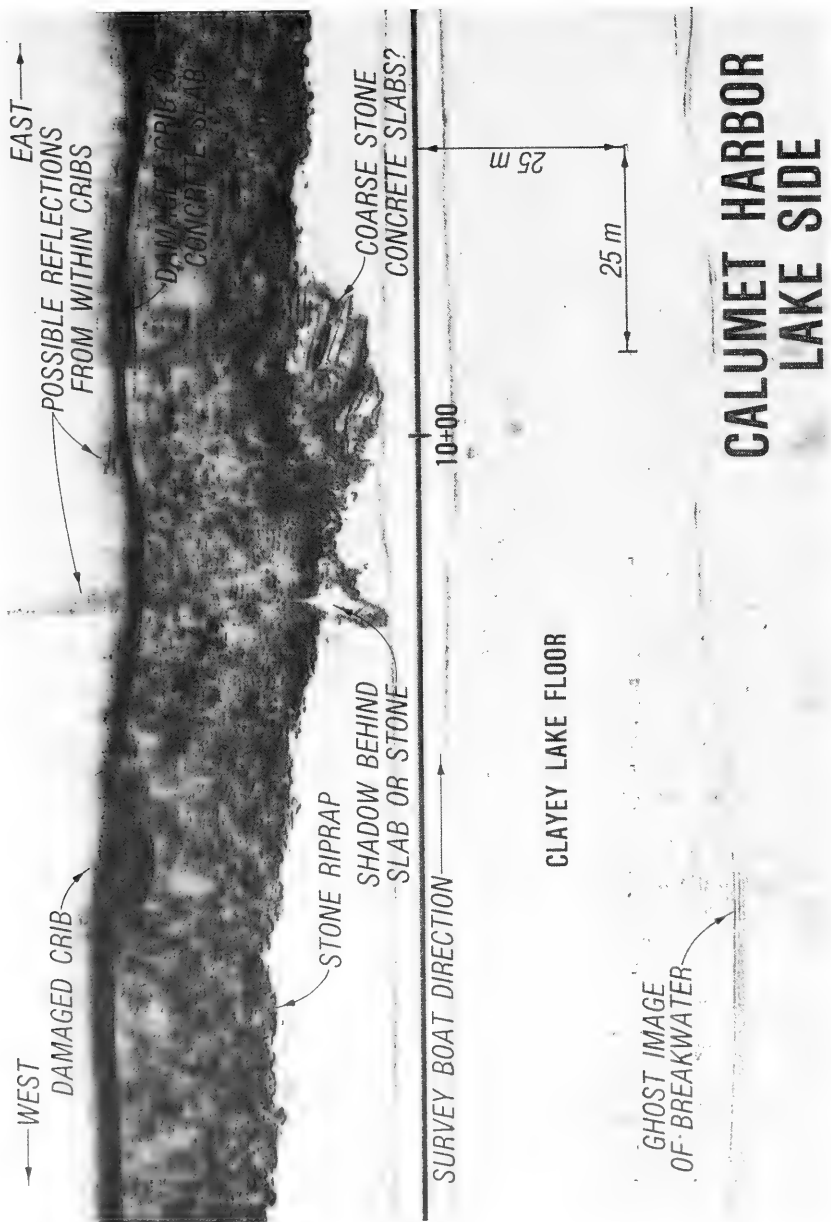
Figure 21. Timber cribs along the lake side of the breakwater at Calumet Harbor, Illinois; section A, 50-m range, 100 kHz

40. Images of the harbor side of section A reveal a section of a crib which appeared to have been displaced slightly inward. The lakeward face of section A had numerous irregular reflections occurring up to 10 ft behind the face of the breakwater (Figure 21). It is hypothesized that these reflections occur at gaps in the damaged face of the cribs where the acoustic signal has entered a void and has reflected from the fill material within the cribs similar to the records of the cribs in Cleveland Harbor shown in Figure 13.

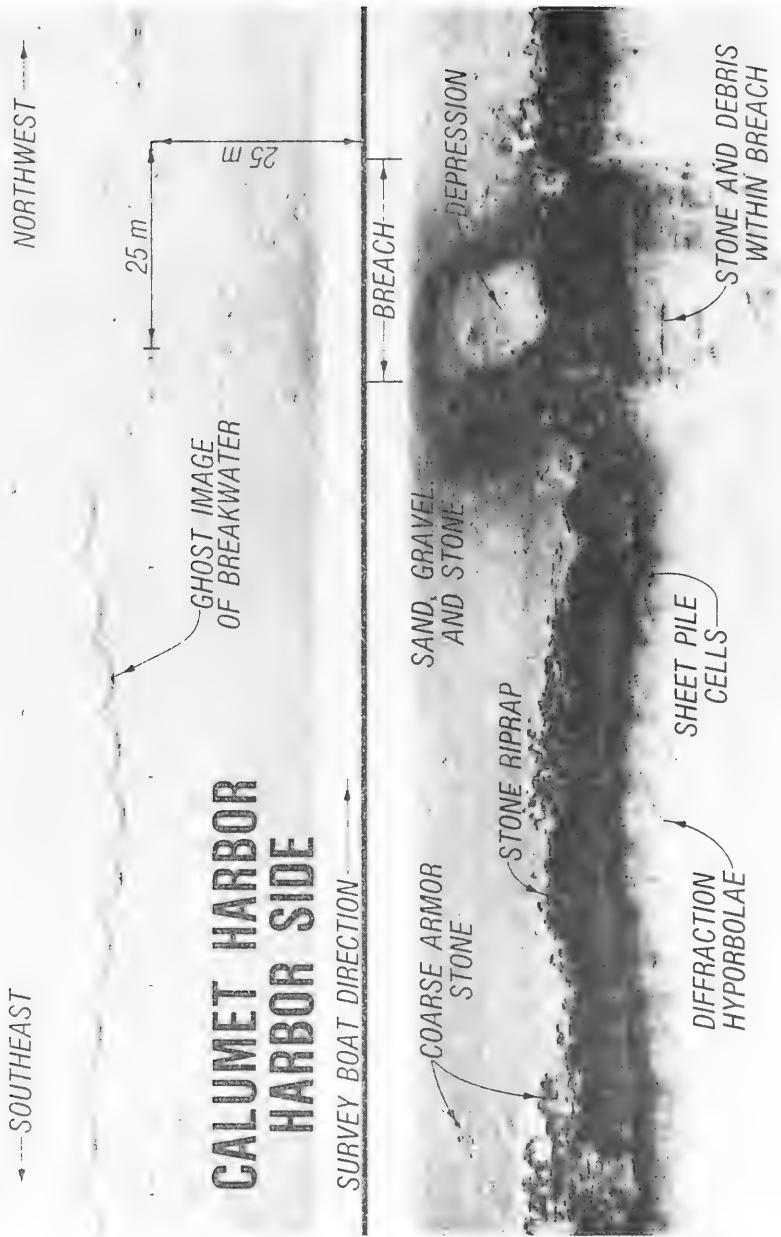
Figure 22. Sheet-pile cells along the harbor side of the breakwater at Calumet Harbor, Illinois

42. The round sheet-pile cells can be clearly seen in the records (Figure 22), and they appear to be in good condition. A breach is evident in

Figure 22 where the cells failed in a 1984 storm. Because of the intensely strong signal return from the vertical sheet-pile walls, minor damage to the walls, such as gaps a few inches wide, may be masked or not resolved. The faint lines and texture on the cell images are diffraction hyperbolae and noise. Diffraction hyperbolae often occur from strong circular reflectors of acoustic energy (like steel pipes and circular sheet-pile cells) due to reflections of energy from the horizontal side lobes. Another unusual feature shown in Figure 22 is the ghost image caused by cross talk from the other channel. Cross talk occurs when the reflected sound energy is so strong that it causes the transducer on the opposite side of the towfish to vibrate.

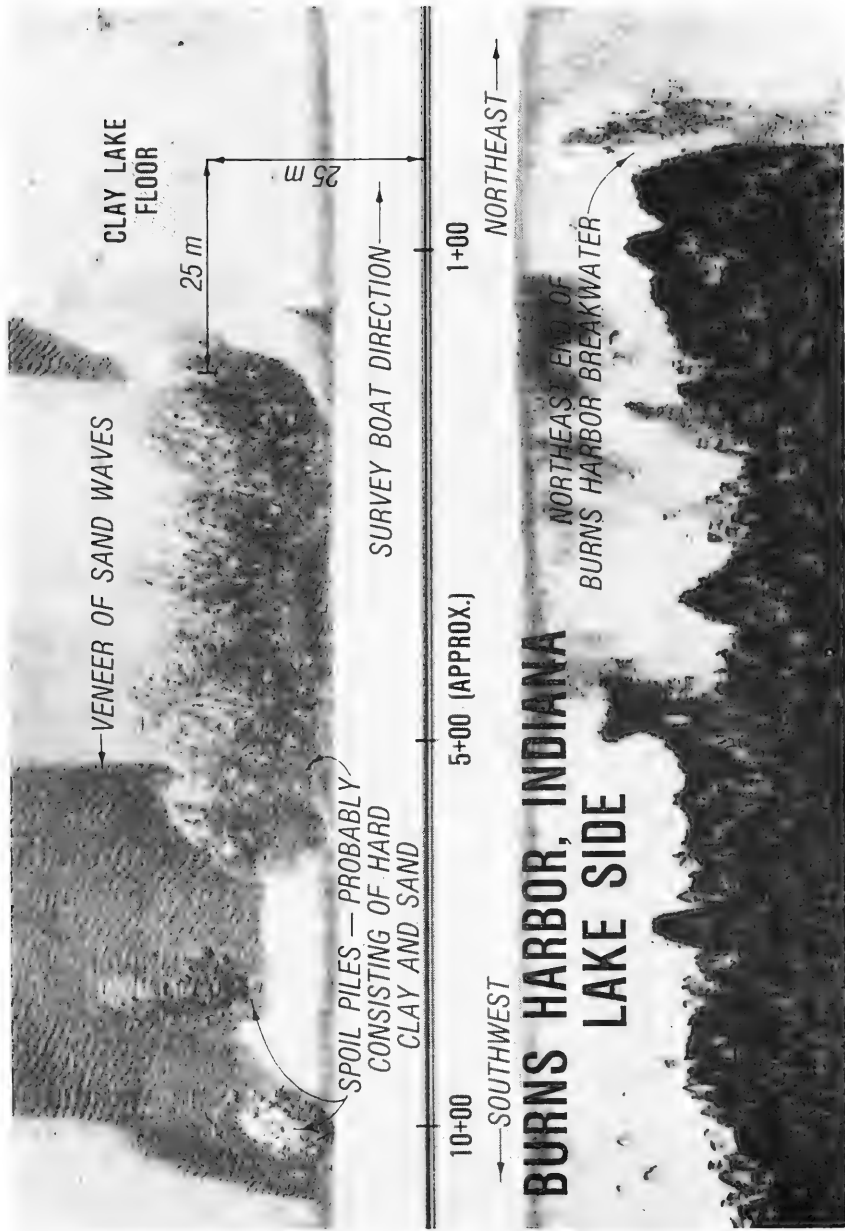
Figure 24. Lakeside image of the Burns Harbor, Indiana, breakwater; 50-m range, 100 khz

44. The lakeside survey conducted in 1985 was not able to provide conclusive evidence of a sand mat extending beyond the base of the structure (Figure 24); also, no conclusive evidence of a sand mat was found on the harbor side. Areas of sand waves occur at distances greater than 30 ft from the base of the structure, but these are believed to be veneers of sand moved by waves and currents over a predominantly clay lake bottom. It is possible that wave action could have redeposited soft clay sediments on top of the sand

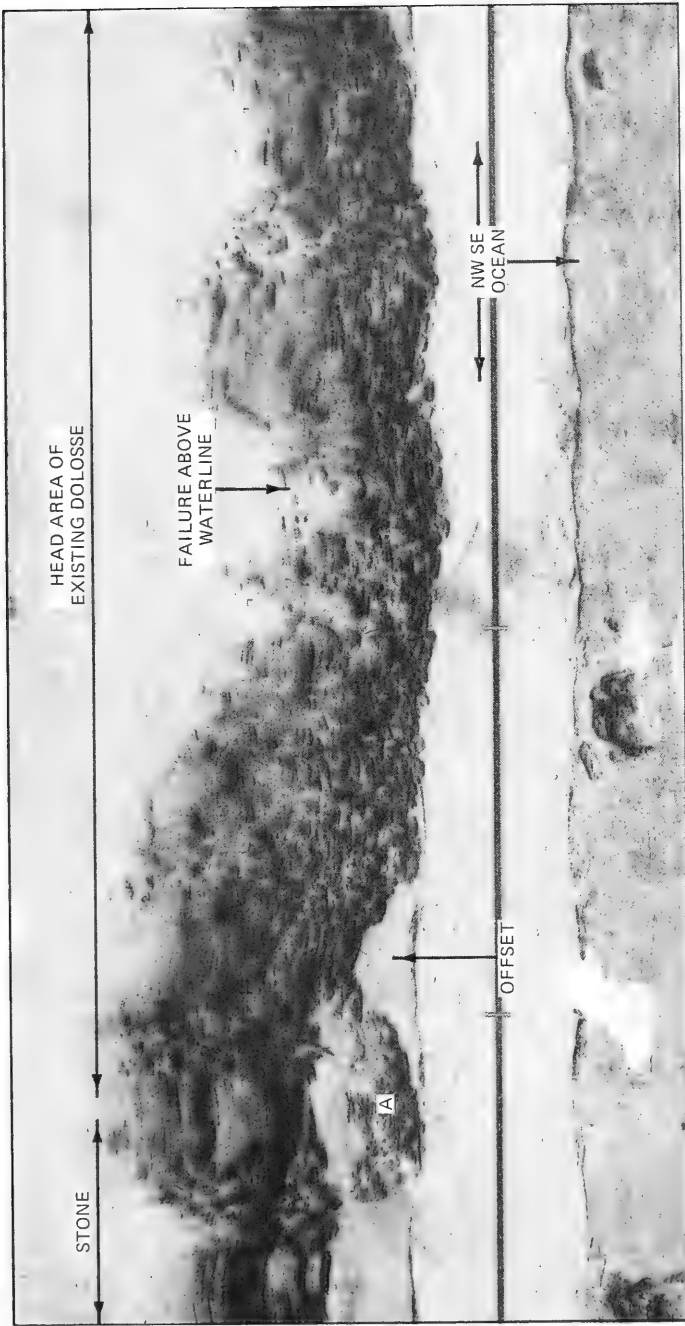
Figure 26. Ocean side of the dolos section of the breakwater at Crescent City, California, 4 October 1985; 50-m range, 100 kHz

48. Apparently the high wave energy of this region had swept the bottom fairly clean, leaving a featureless sand veneer. There was little evidence of exposed dolosse pieces or other debris in the record (Figure 26). A large offset in the toe of the structure (point A on both this figure and Figure 27) can be seen at the transition between dolos cover and stone cover. This offset does not correspond to any failure above the waterline; however, there

is a failed zone located approximately 100 ft to the right of the toe offset. Failure above the waterline has pushed the armor units out toward the ocean. (Note the offset at left center; point A is in the same location in this figure and Figure 27 for reference.)

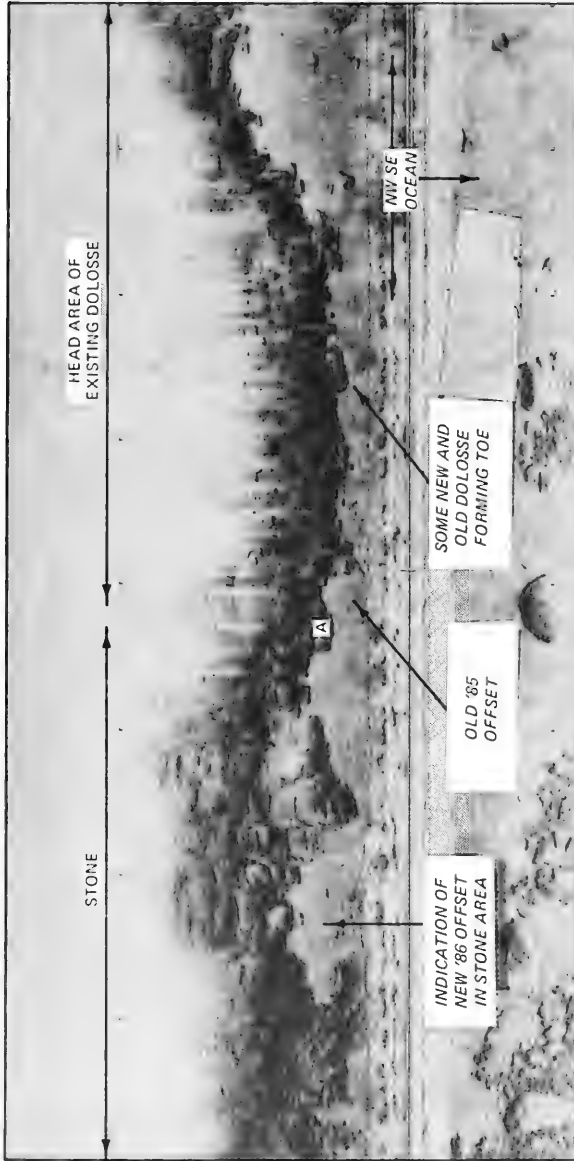
Figure 27. Ocean side of the dolos and rock sections of the breakwater at Crescent City, California, 26 July 1986; 75-m range, 100 kHz

49. A second survey in July 1986 (Figure 27), shows essentially the same results, but with some important differences. (Figure 27 was taken at a 75-m range, while Figure 26 was taken at a 50-m range; consequently distances perpendicular to the line of travel are compressed on Figure 27.) By the time the second survey had been taken, a contractor had already started to replace some of the damaged and missing dolosse, making the toe well defined. Also, the above-water failure zone had been repaired. There appears to be a section farther inland that exhibits the same conditions as offset shown in the 1985 survey (Figure 26). However, Figure 26 does not extend far enough to the left (northwest) to show this section. The condition of this hole will be examined closely in future surveys.

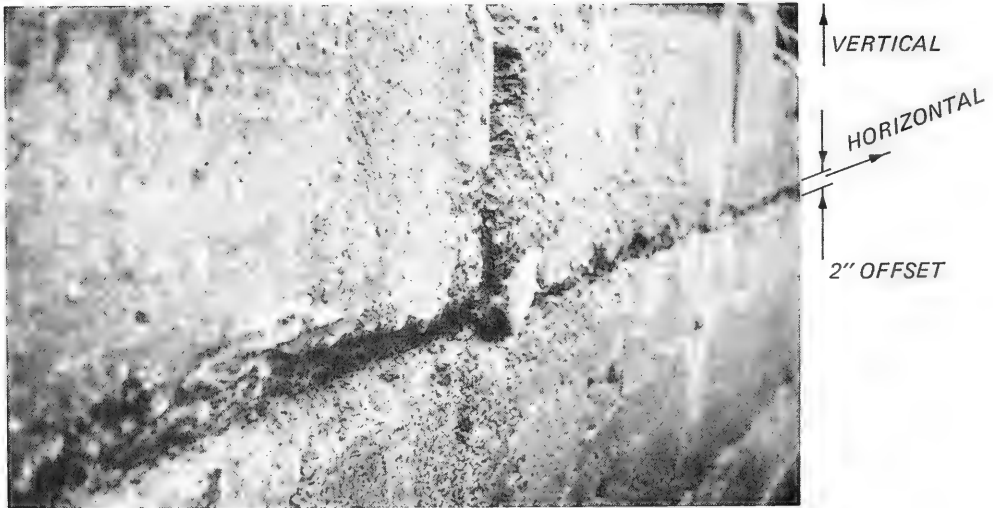
Figure 34. Photograph of offset (approx 2 in.) between concrete caissons in Quebec Harbor, Canada

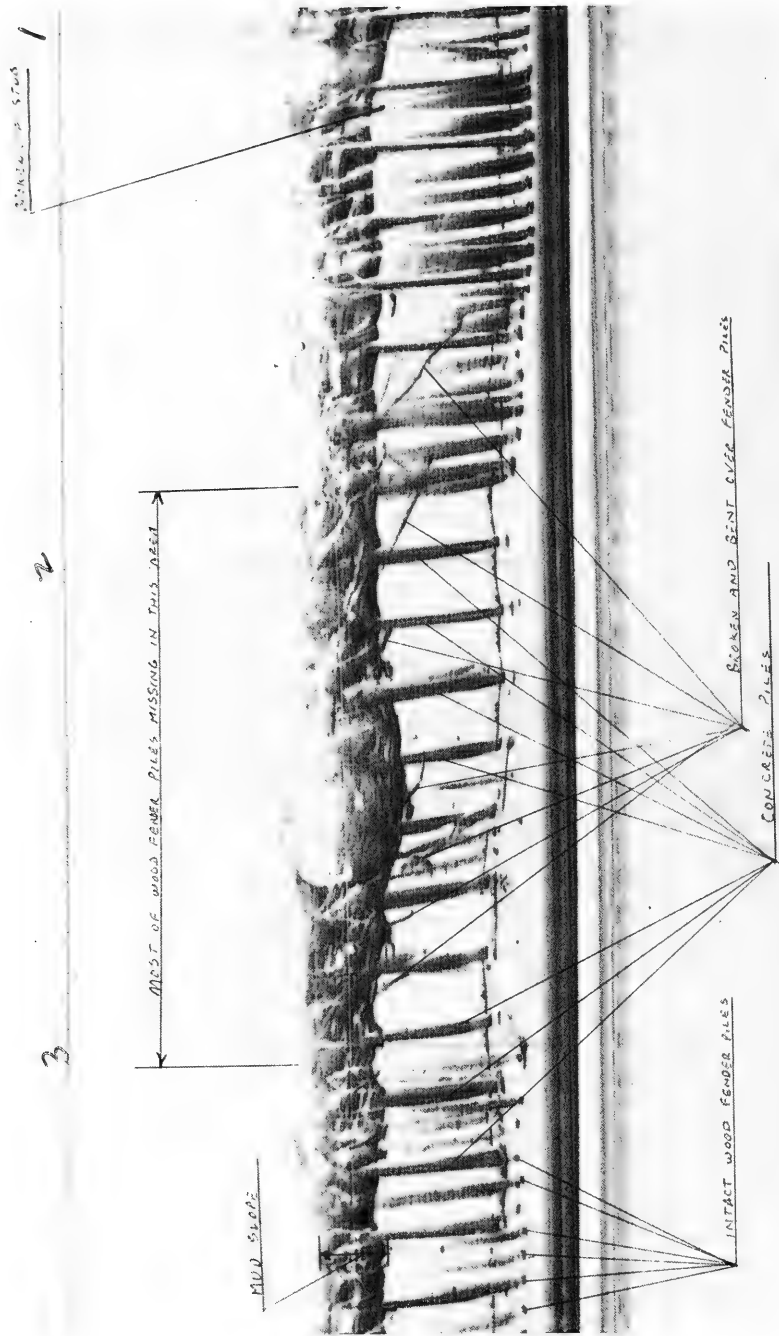
Figure 35. Navy pier in Norfolk, Virginia; 500 kHz

63. The US Navy contracted with Steadfast Marine, Inc. (1982), to perform an inspection of some of the Piers at their facility in Norfolk, Virginia. The quality of the records was improved by rotating the fish, allowing it to look down the pilings from the surface. As a result, the fender pilings stand out in greater detail than the concrete support piles which are some distance behind the wooden fender piles (Figure 35). Also, intact wooden piles, concrete piles, and damaged wooden piles can be seen in Figure 35.
